## **MARK 66 APPLICATION**

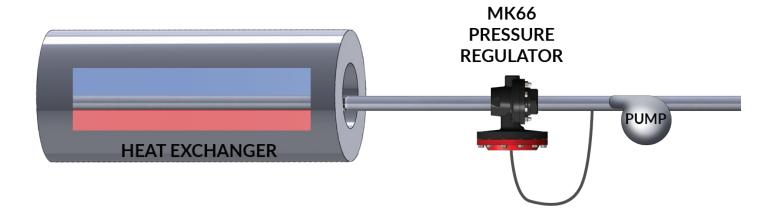
The customer wanted a valve that would require no electircity and that would shut off the steam line when there was no water present in the heat exchanger lines. Upn loss of water pressure, the Mark 66 closes and the steam flow stops. The Mark 66 was mounted upside down to allow the dome to drain.
